# Dry-out behaviour of cross-laminated timber (CLT) edge conditions in roof assemblies: A field study

Dorothy Johns <sup>\*</sup>

, Russell Richman

Department of Architectural Science, Faculty of Engineering and Architectural Science, Toronto Metropolitan University, 325 Church St., Toronto, ON M5B 2M2, Canada

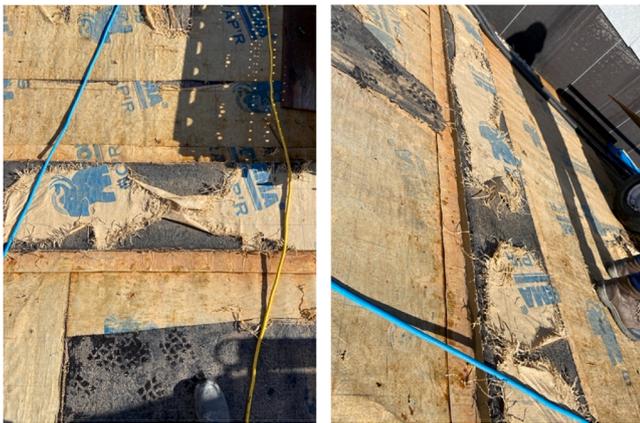
to moisture and wetting for a much longer period than anticipated. Furthermore, the initial application of the vapour retarder directly to the CLT roof deck was not successful (Fig. 3), moisture in the wood caused the vapour retarder adherence to the CLT roof deck to fail. The CLT required drying prior to the installation of a new vapour retarder, several drying methods were tested during this period – the most effective method was to tent and mechanically vent the entire roof surface while also forcing warm air under tarps at specific vulnerable locations and areas where surface MC readings were consistently reading well above 30 %, refer to Fig. 4.

Fig. 3. TRCA site photos – failed vapour retarder membrane (at protruding beams)

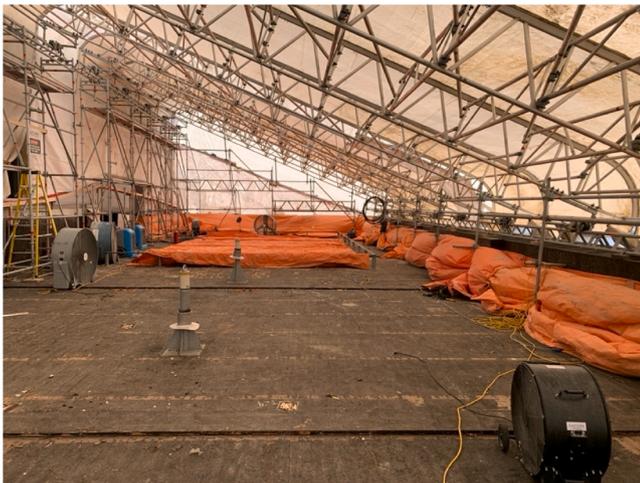
Fig. 4. TRCA site photo – tented roof with fans and tarps on high MC area

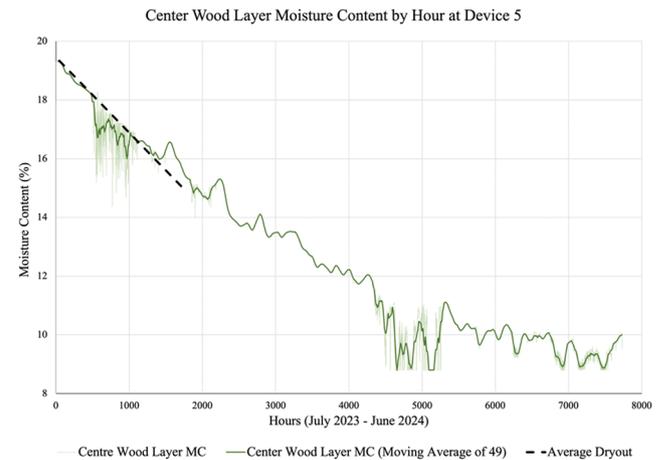
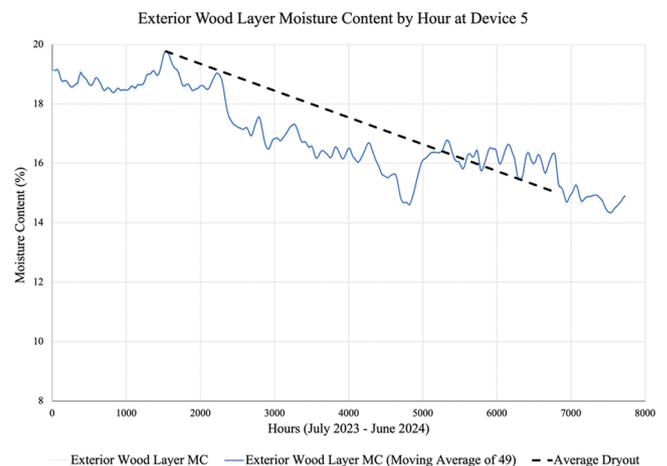
As illustrated in Fig. 10, the peak MC value in the center wood layer at Device 5 was 19.33 % and it took 1735 hours, or just over 72 days to reach  $\leq 15\%$  over a minimum of two weeks. The peak MC value in the exterior wood layer at the same device (5) was a very similar 19.77 % but it took 6819 hours, or almost 8.5 months to “dry” as previously described. Evidently, this created variation in the dry-out rates, where

Fig. 10. Centre (above) and exterior (below) wood layer dry-out behaviour at Device 5.

the center wood layer was drying at a rate of  $-0.0616\%$  / day and the exterior wood layer above dried at the slower rate of  $-0.0217\%$  / day as illustrated by the linear average dry-out models indicated in Fig. 10. The center wood layer’s linear regression model has a coefficient of determination ( $R^2$ ) of 0.92, whereas the exterior layer has an  $R^2$  of only 0.57. The slower and more volatile conditions at the exterior wood layer, as indicated by the calculated dry-out rate and the  $R^2$  value respectively, are likely a result of the application of the impermeable membrane directly to the CLT prior to reaching MC below 19 % inhibiting drying towards the exterior of the CLT panel.

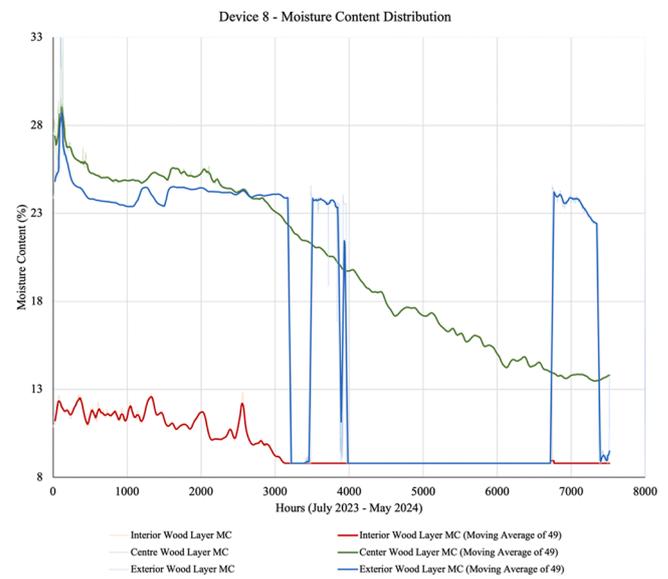
Fig. 12. Moisture content distribution in “wet” CLT roof panels at Device 8.

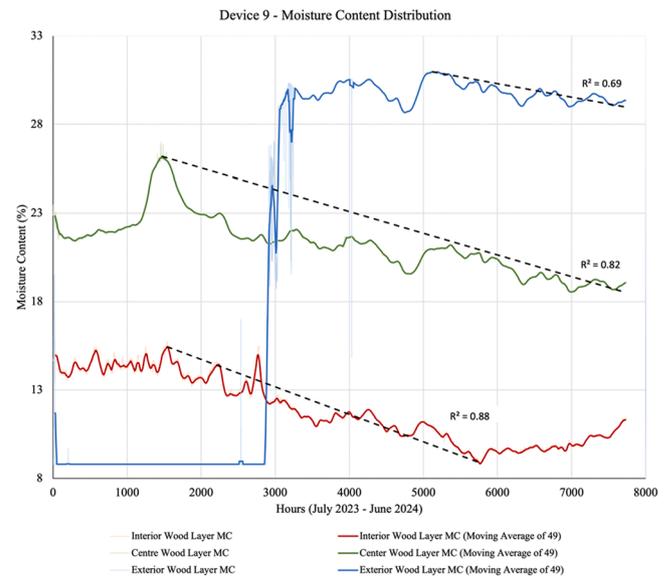
Fig. 13. Moisture content distribution in “wet” CLT roof panels at Device 9.

Device 9 indicates very consistently high levels of moisture in the exterior wood layer as well as consistent moisture content in both the center and interior layers, with minimal to no indication of any dry-out occurring during the data collection period. The rapid spike in MC in only the exterior wood layer at around 3000 hours is indicative of a sensor malfunction prior to the spike and it can be assumed that the MC was consistent around 30 % prior to the spike, for the entire data collection period and illustrated in Fig. 13. The concern at this monitored location is that there is no indication of dry-out in the exterior wood layer in the first 11 months of monitoring, and that the center wood layer shows indication of very slow dry-out only. In Device 6, the concern is that the center wood layer is showing signs of further wetting/moisture loading over the period monitored and the exterior wood layer is also only indicating very slow dry-out.

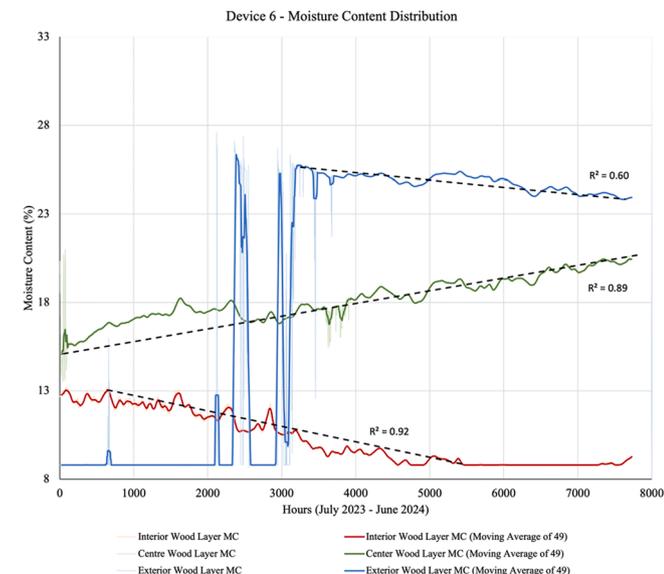
Fig. 11. Moisture content distribution in “wet” CLT roof panels at Device 6.

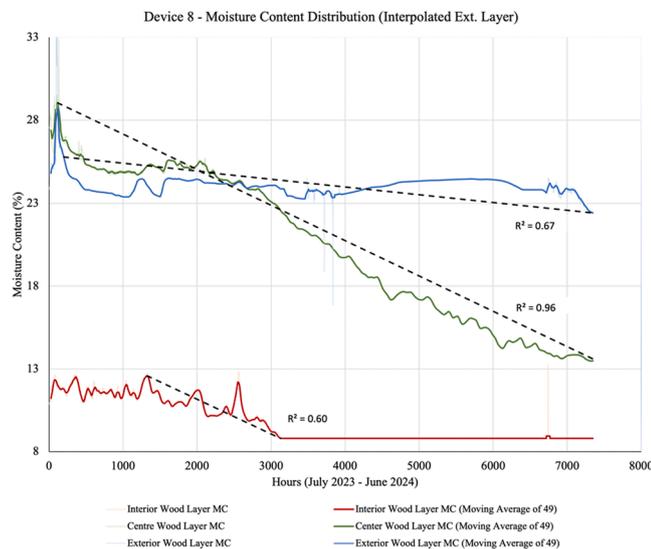
Device 8 is missing periods of data from the exterior wood layer, however given the slope and pattern of this data, the missing hours between approximately 4000 and 6700 can be interpolated and assumed to fluctuate between the data points on either side of the gap, which would be around 24 % MC consistently, refer to Fig. 14. Given this

Fig. 14. Device 8 moisture content distribution including interpolated exterior wood layer data.

interpolation of the data, the dry-out behaviour of Device 8 emulates the dry-out behaviour observed in the baseline “dry” monitoring locations observed on the East side of the building except at much higher MC values and with much longer dry-out periods and consequently slower dry-out rates. In fact, the exterior wood layer only began to show signs of drying approximately 500 hours (21 days) prior to the end of the period illustrated, which was approximately 10.5 months after the data collection began and almost one year after the exterior roof assembly was installed on the CLT roof deck.

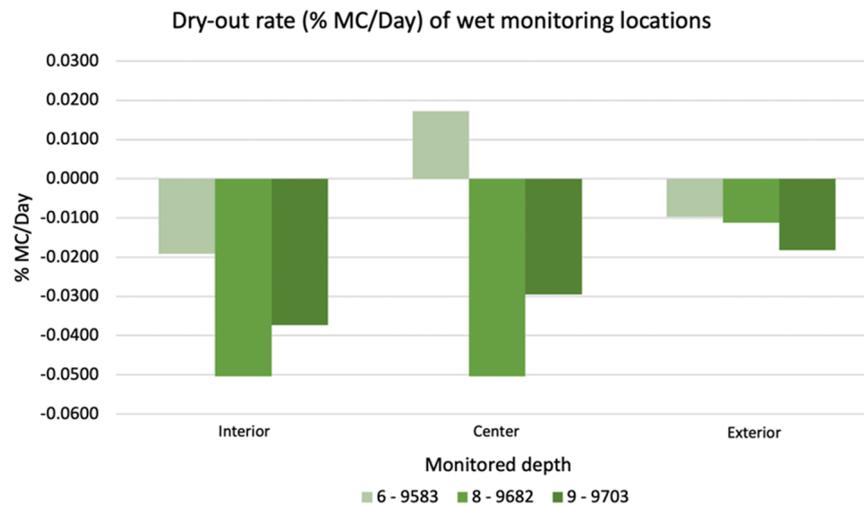
The MC/day (%) rate from Table 3 is illustrated in Fig. 15. This clearly demonstrates the consistently slower dry-out rates at the exterior wood layer compared to the center and interior wood layers. It also indicates the positive rate of the center wood layer at Device 6 which indicates moisture absorption, not dry-out. It is possible that the moisture loading observed at the center wood layer is a result of the impermeable membrane applied to the exterior wood layer which could be inhibiting dry-out towards the exterior thereby changing the direction of moisture transport towards the interior of the CLT. This would mean moisture was being transported from the higher MC exterior layer through the CLT to center wood layer. However, given that the other two

wet monitoring locations do not show the same trend at the centre wood layer it is more likely that there is out-of-plane liquid water movement through the CLT that is being captured at this particular location. A prevalent type of damage in CLT panels is pronounced cracking in the gluelines and lamellas of adhered products due to swelling and shrinkage of wood layers caused by moisture fluctuations [7].

Fig. 15. CLT dry-out rates per measurement depth at 'wet' monitored locations.
