# Dry-out behaviour of cross-laminated timber (CLT) edge conditions in roof assemblies: A field study

Dorothy Johns <sup>\*</sup>

, Russell Richman

Department of Architectural Science, Faculty of Engineering and Architectural Science, Toronto Metropolitan University, 325 Church St., Toronto, ON M5B 2M2, Canada

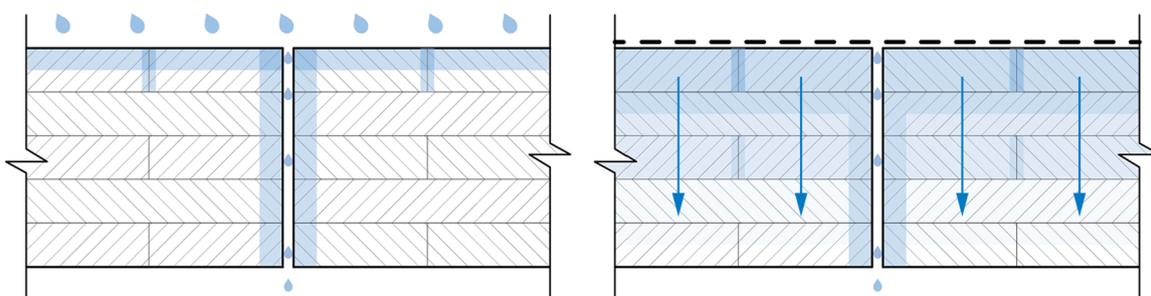
lumber, enabling rapid moisture uptake parallel to the wood grain [5]. The industry has reported a large quantity of end-grain water absorption at CLT panel edges, particularly where the end grain is not exposed to dry, warm air [17]. Joints between CLT roof panels are therefore at high risk of wetting as well as sustained elevated moisture content (MC > 19 %) because there is little to no opportunity for dry-out within the joint and towards the exterior of the CLT roof panels due to impermeable exterior materials [18], refer to Fig. 1. Horizontal assemblies, such as roof and floor assemblies, are also at greater risk of exposure to standing water during construction and several field monitoring studies have indicated that critical MC occurred after single rain events – suggesting that an accelerated construction schedule is not sufficient to mitigating moisture ingress in mass timber particularly where wood end grain is exposed [17].

Fig. 1. Water uptake at CLT panel edge and roof surface, adapted from [19].

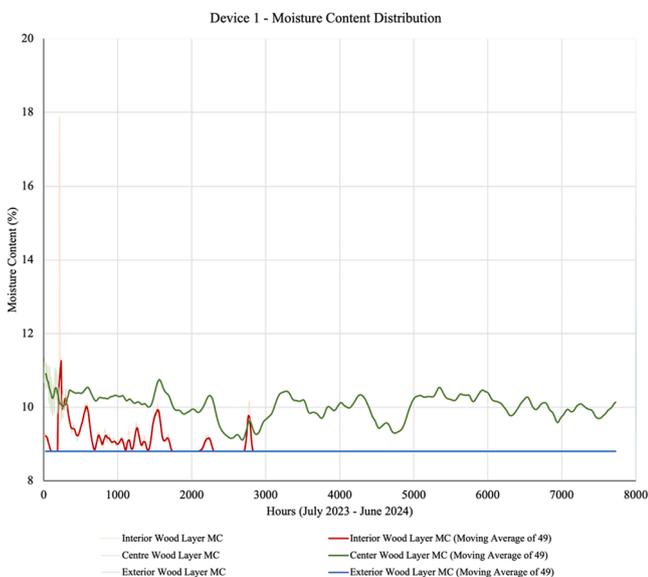
conditions and processes in North America. These two panels show no moisture measurements above the device baseline threshold of 8.8 % in the interior wood layers. In both monitoring locations, the exterior wood layer shows some moisture fluctuations between 8.8 – 12 % between the initial 0–3000 hours, which is approximately the first four months of monitoring from early July 2023 through early November 2023. The center wood layer in both monitoring locations fluctuates consistently between approximately 9 – 11 % MC during this period, which is also indicative of dry conditions. Any initial dry-out period observed in both monitoring locations is negligible (see Fig. 8 and Fig. 9) as such, additional dry-out behaviour was not conducted for these panels.

Fig. 8. Moisture Content Distribution in Baseline (“Dry”) CLT Panel for Device 1.

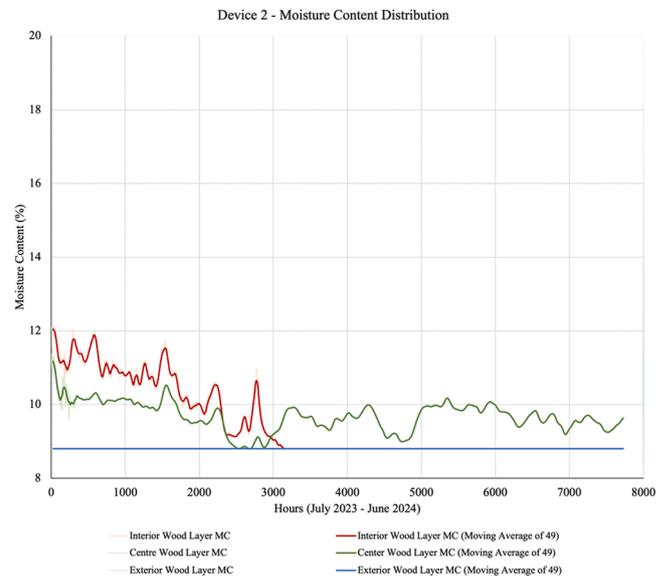
Fig. 9. Moisture Content Distribution in Baseline (“Dry”) CLT Panel for Device 2.
